George Eastman House Photograph XRF Analysis

Below are 5 plots of analysis of 3 different photograph using the Bruker Handheld xrf system.

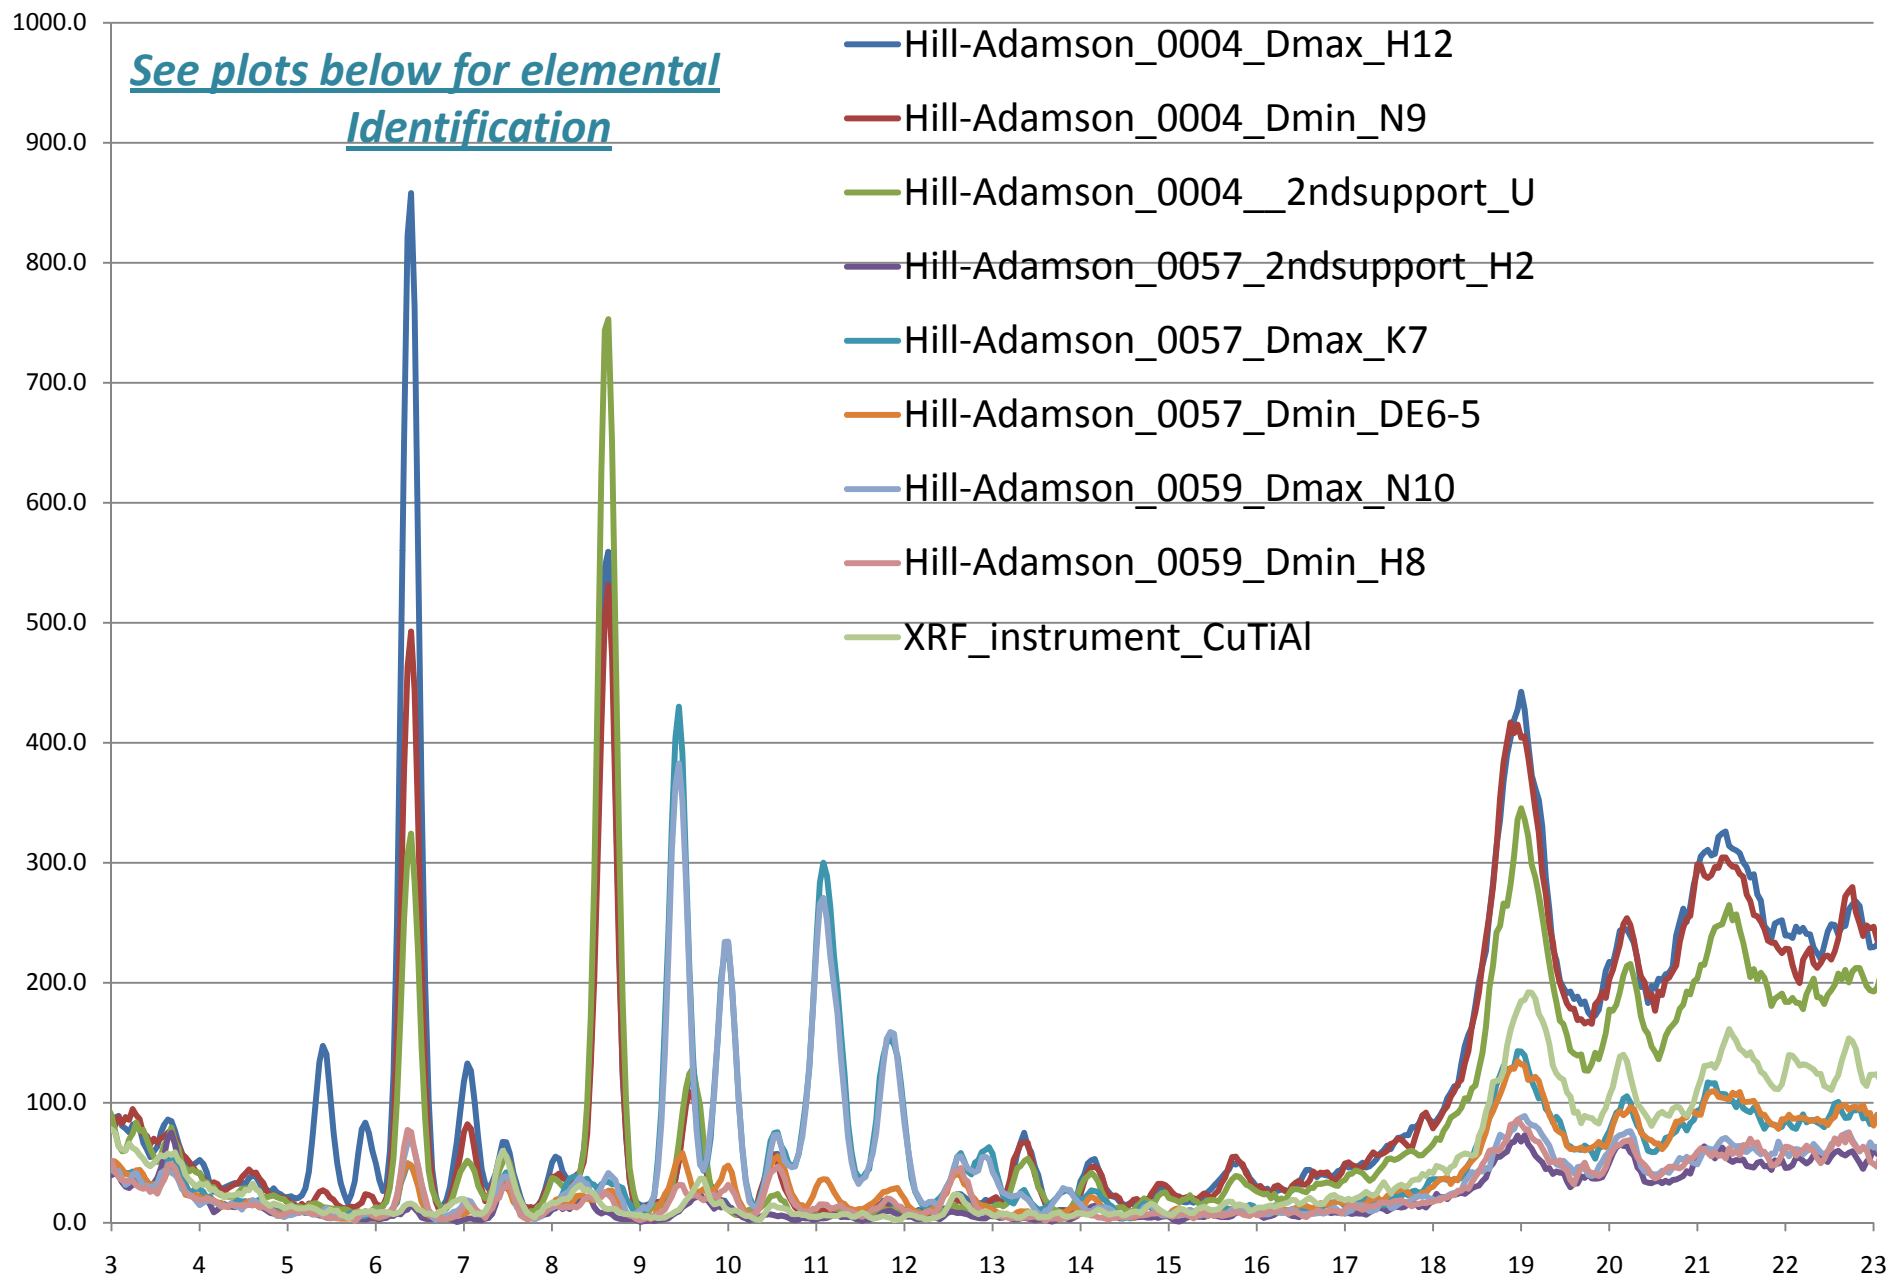
1. The first plot contains all the xrf elemental analysis of both D min and D max and a piece of plastic to determine what elements are from the detector itself.
2. The second is the D min and D max of photo 57
3. The third is the D min and D max of photo 4
4. The fourth is the D min and D max of photo 59
5. The fifth is the difference of the D max minus D min for the 3 photos

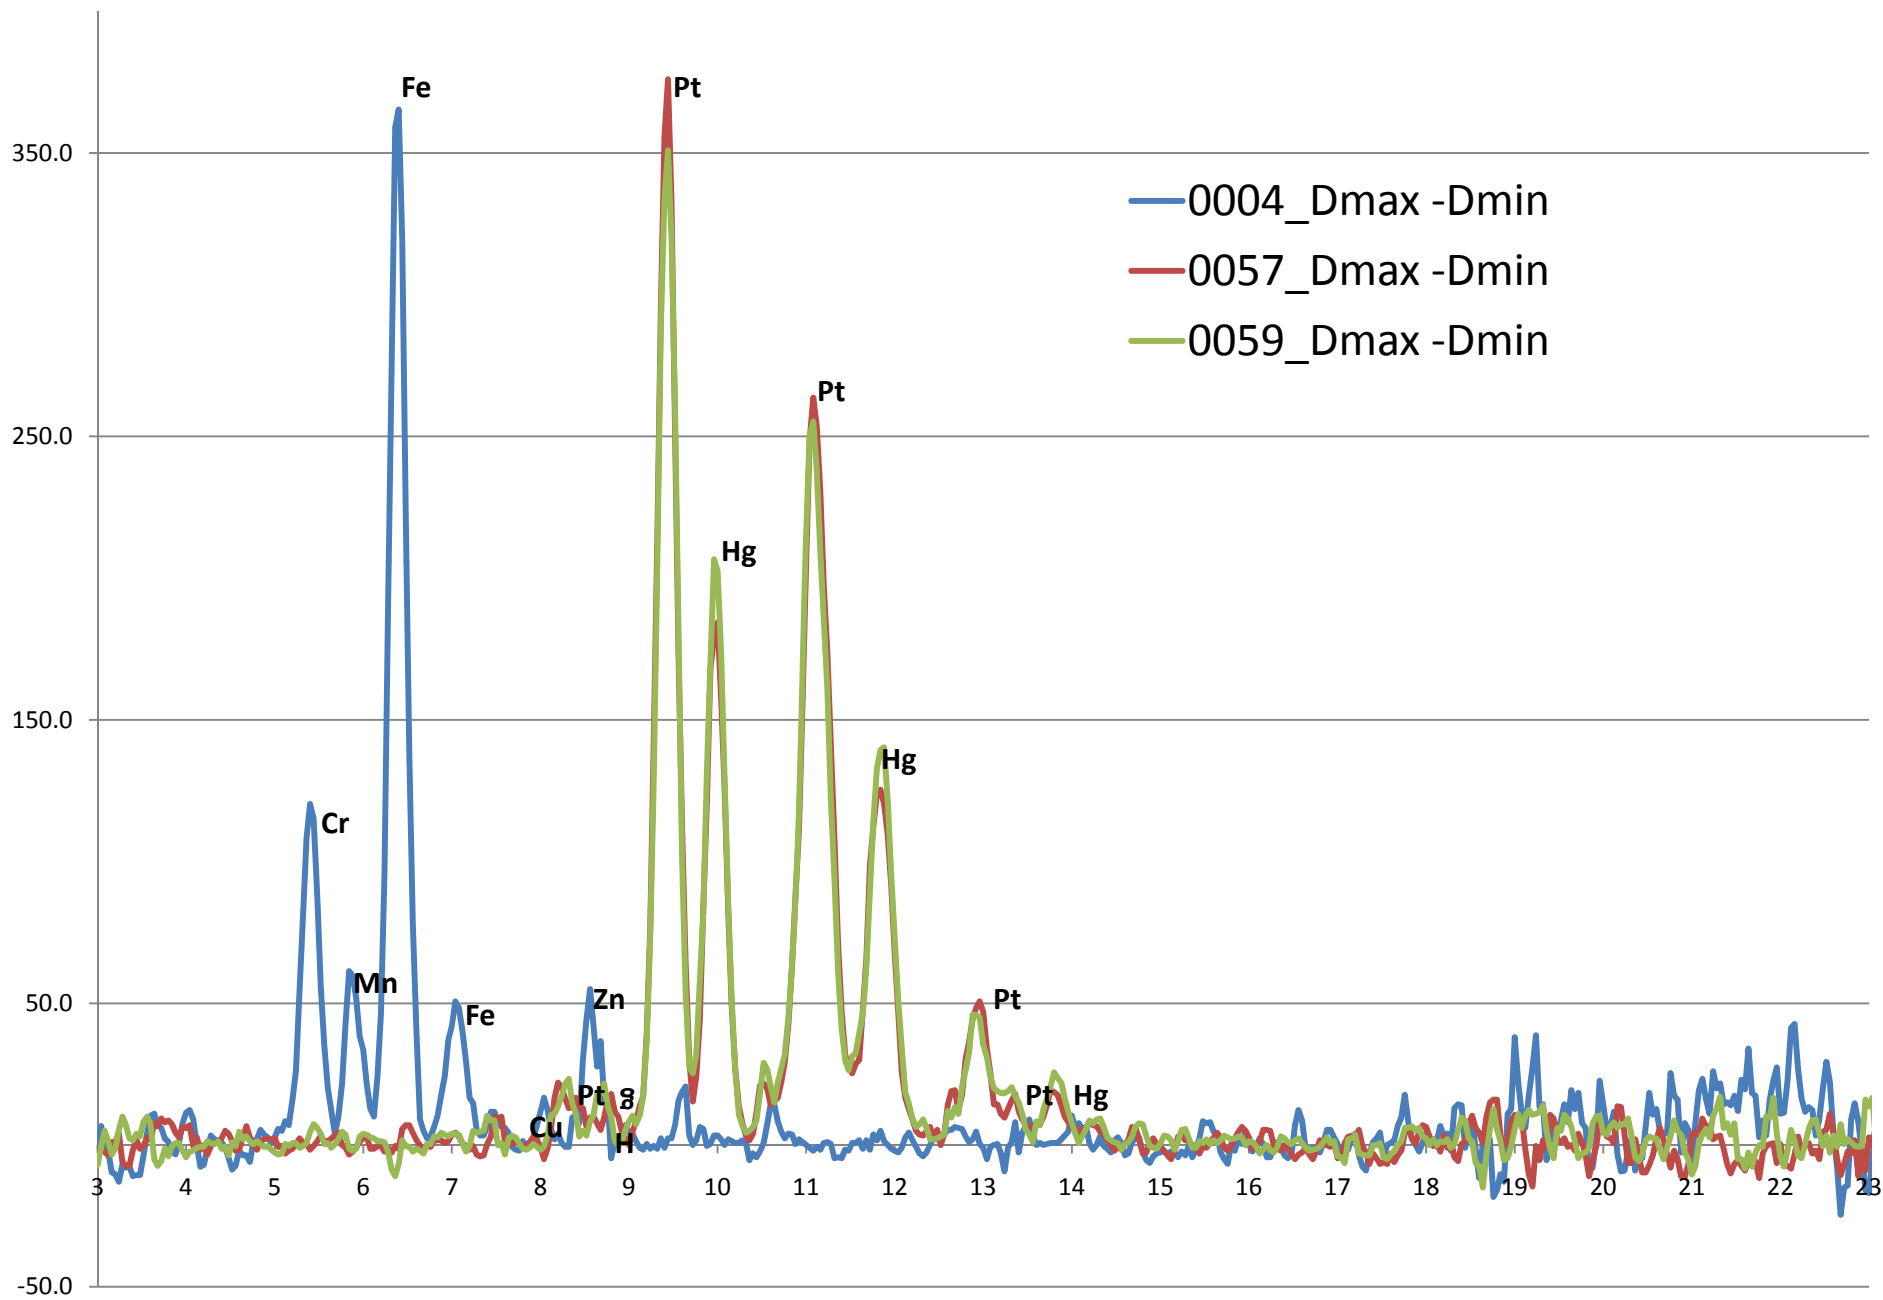
From the differences shown in slide 5 of D max and D min it is clear that the images in 56 and 57 are made from Pt and Hg and the image in 4 is made from Cr, Mn, Fe, Cu and Zn.
